# **Damage Study and Future Direction for Structural Design Following the Tuscaloosa Tornado of 2011**

**David O. Prevatt, Ph.D., P.E., University of Florida, Gainesville, FL**  
**John W. van de Lindt, Ph.D., University of Alabama, Tuscaloosa, AL**  
**Andrew Graettinger, Ph.D., University of Alabama, Tuscaloosa, AL**  
**William Coulbourne, P.E., Applied Technology Council, Rehoboth Beach, DE**  
**Rakesh Gupta, Ph.D., Oregon State University, Corvallis, OR**  
**Shiling Pei, Ph.D., P.E., South Dakota State University, Brookings, SD**  
**Samuel Hensen, P.E., Simpson Strong Tie, Pleasanton, CA**  
**David Grau, Ph.D., University of Alabama, Tuscaloosa, AL**

July 27, 2011

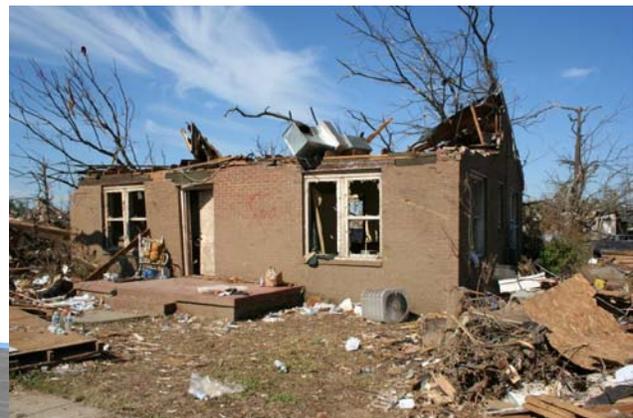
**Roof uplift:** This failure mode is defined as the roof framing being lifted off the walls leaving the ceiling exposed inside and the tops of the exterior walls with no roof rafters attached. Figure 4.1 illustrates this failure mode.

Figure 4.1: loss of roof assembly

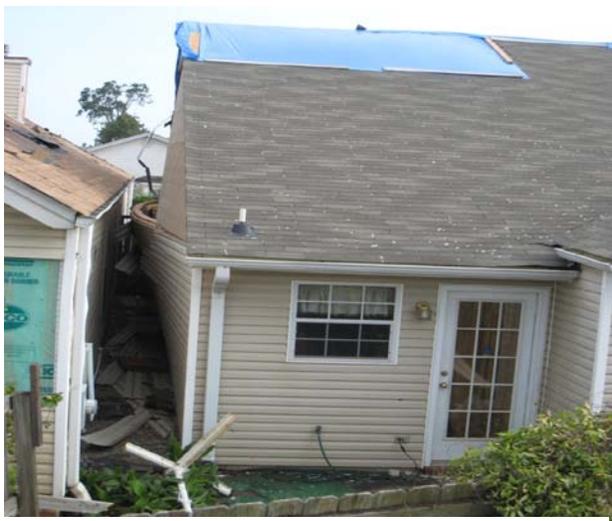
Figure 4.2: Exterior walls pushed out by high internal wind pressure

**Exterior walls pushed out:** This failure is indicative of excessive internal wind pressure pushing the exterior walls out of plumb. This could occur at any of the exterior walls including those with gable ends. The roof may or may not be attached when this occurs. Figure 4.2 illustrates this failure mode.

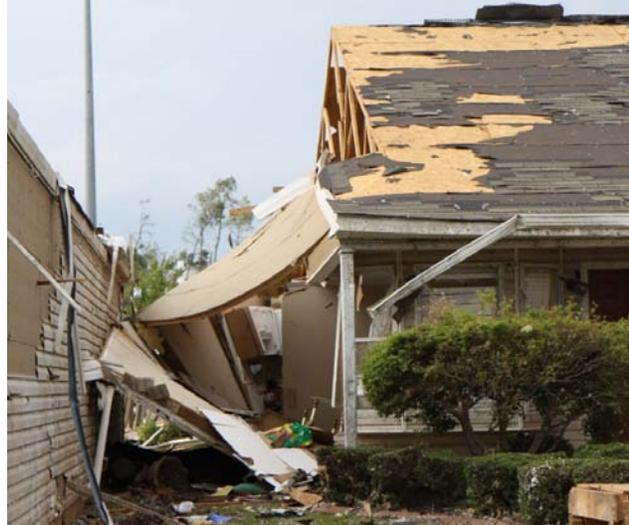
This failure mode could be indicative of excessive internal wind pressure, but it is also possibly indicative of excessive leeward pressure created by suction of the wind field as it passes by the building. Figure 4.3 illustrates this failure mode.

*Figure 4.3: Exterior wall and gable roof end pulled out as a result of high leeward winds*

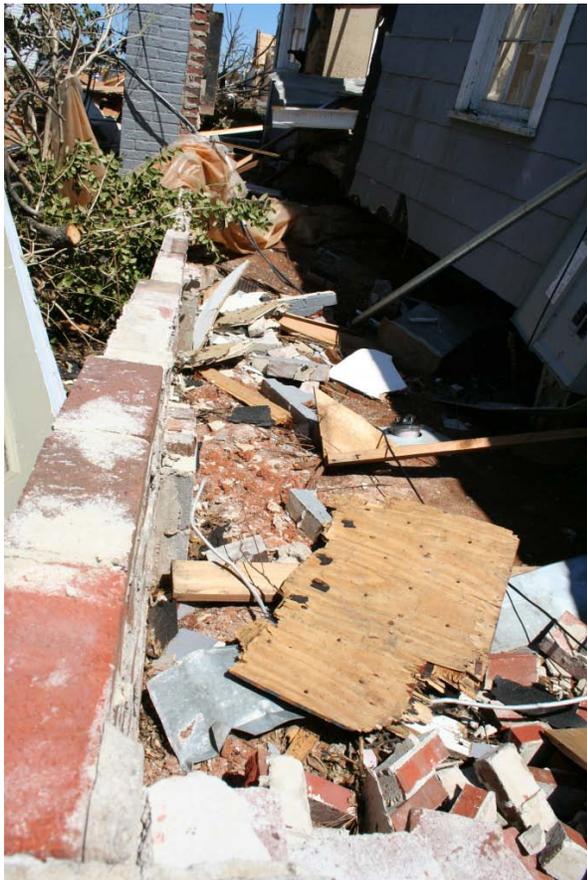
*Figure 4.4 House lifted off its foundation. Chimney shown to the right approximately 5ft over.*

This failure mode is indicative of high lateral windward pressure on a building that is inadequately attached to the foundation. Figure 4.4 illustrates this failure mode.

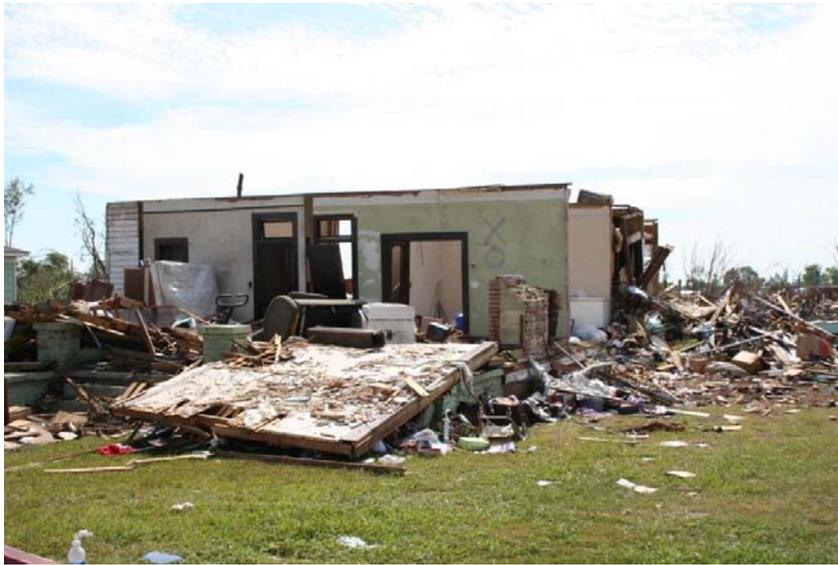
*Figure 4.5 Interior walls collapsed*

This failure mode occurs after the roof and exterior walls have failed. There is typically minimal connection between these interior walls and the roof system so losing the roof allows the interior walls to collapse. Figure 4.5 illustrates this failure mode.

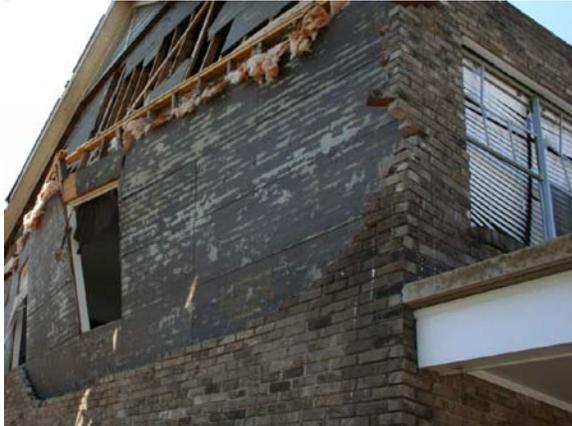
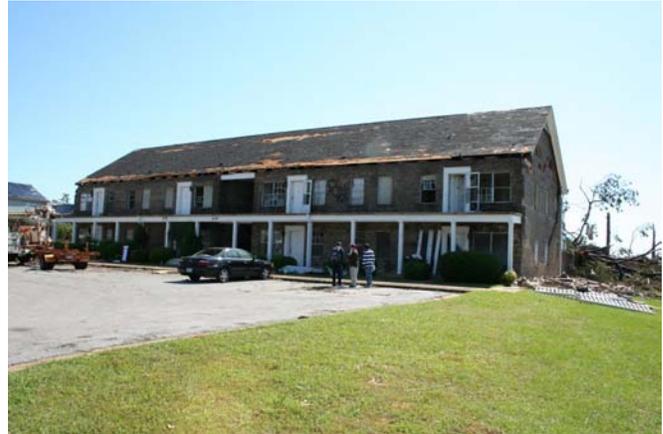
*Figure 4.6 Two-story apartment building with gable end failure and brick veneer failure.*

The wood-framed building appeared to be built in the 1960's. Winds broke the windows and then created sufficient interior pressure to fail the brick façade and push out one gable end wall. The damage sustained included:

- Less than 20% of the roof covering
- Broken windows and doors
- Brick façade failure
- Gable end wall ballooned outward
- Exterior fiberboard sheathing damaged by wind at gable ends

The Degree of Damage on the EF scale for multi-story apartment buildings is 2, which suggests wind speeds in the range of 82 – 121 mph with an expected speed of 99 mph.

1. The construction observed suggests brick ties at spacing that was larger than the current IBC requirements.
2. There is no wind-borne debris protection for the glazing.
3. There is little resistance from wind pushing up the interior 2<sup>nd</sup> floor ceilings into the attic space.
4. The gable end wall was pushed out by wind.

5. There was some evidence that the double top wall plates were connected into the gable end as the double top plates were cracked.
6. There was no evidence that the building experienced lateral movement of the 2<sup>nd</sup> floor in relation to the first floor; the building walls were not pushed out of the vertical plane.
7. There were gable end vents that probably helped relieve the wind pressure in the attic as there was no loss of roof sheathing.
8. Roof damage was limited to shingles and underlayment.

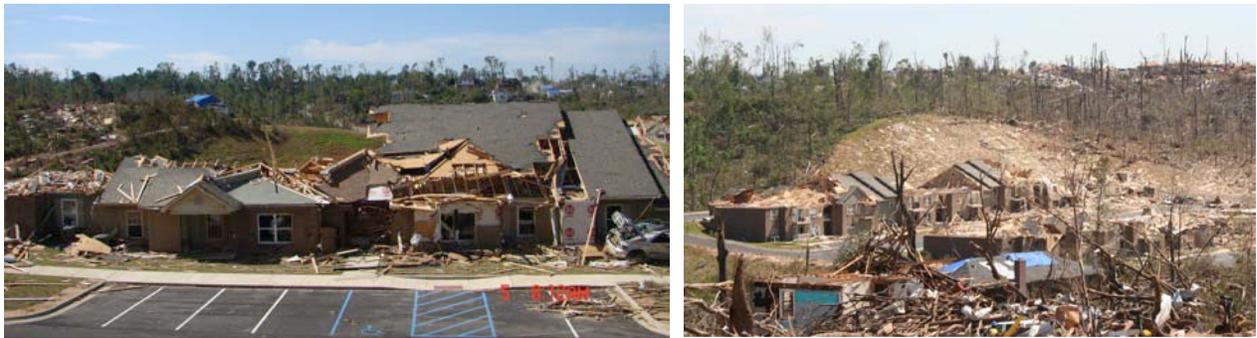
*Figure 4.8: Badly damaged and partially destroyed apartment complex*

These wood-frame buildings were built in 2010. It appears that the terrain at this location affected the wind speeds. This area is lower than adjoining land to the southwest; damage at the extreme southwest end of this complex was primarily roof and upper floor damage while damage levels increased as the storm moved toward the northeast. Damage at the extreme northeast included concrete slabs being swept clean by the winds. Undoubtedly, debris from the southwest end struck the other parts of the complex making total destruction of the northeast end more likely. The damage sustained included:

The Degree of Damage on the EF scale for multi-story apartment buildings is 6, which suggests wind speeds in the range of 155 - 205 mph with an expected speed of 180.

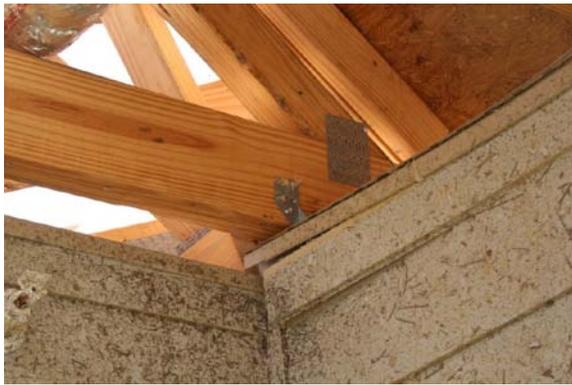
1. Roof trusses were connected to the top wall plates with hurricane clips (see Figure 4.9).
2. The date on the roof sheathing suggests a construction date of approximately 2010.
3. The exterior wall sheathing was OSB.
4. Windows and doors were broken with wind-borne debris.
5. Anchor bolts attaching the sill plate to the concrete were spaced approximately 6 feet on center in a few locations that were visible.
6. Some sill plates had been attached with only cut nails (see Figure 4.10).

*Figure 4.9 Photograph of installed hurricane clip*

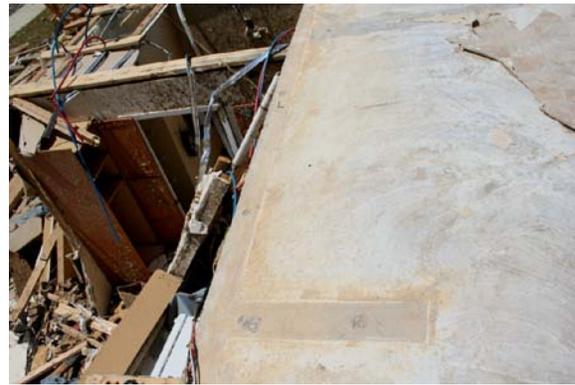
*Figure 4.10 Slab swept clean with cut nails at edge*

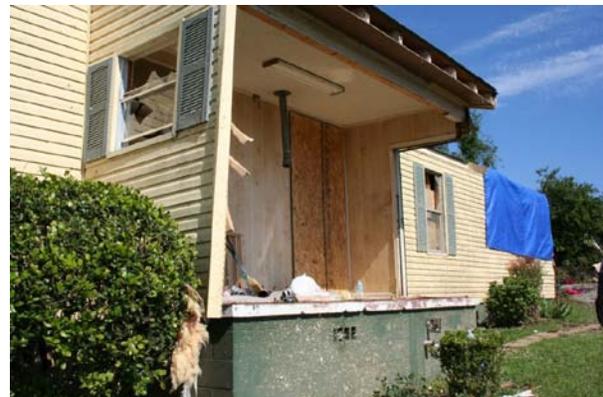
*Figure 4.11: Single family dwelling with moderate EF/damage*

The wind pressure and wind-borne missiles broke a few windows. The wind pressure tore off some vinyl siding that had been installed over the original fiberboard siding. While the windows were broken, there was not sufficient uplift pressure to create any damage to the roof sheathing or roof framing. There was a poorly attached wall on the east side of the house that was torn off by wind pressure or was hit by debris. The damage sustained was:

- More than 20% of the roof shingles were removed
- Siding on both the front and east side was torn off
- Windows are broken
- One wall of a small addition on the west side was removed (see Figure 4.12)
- Roof framing is completely intact
- All primary walls of the house are standing

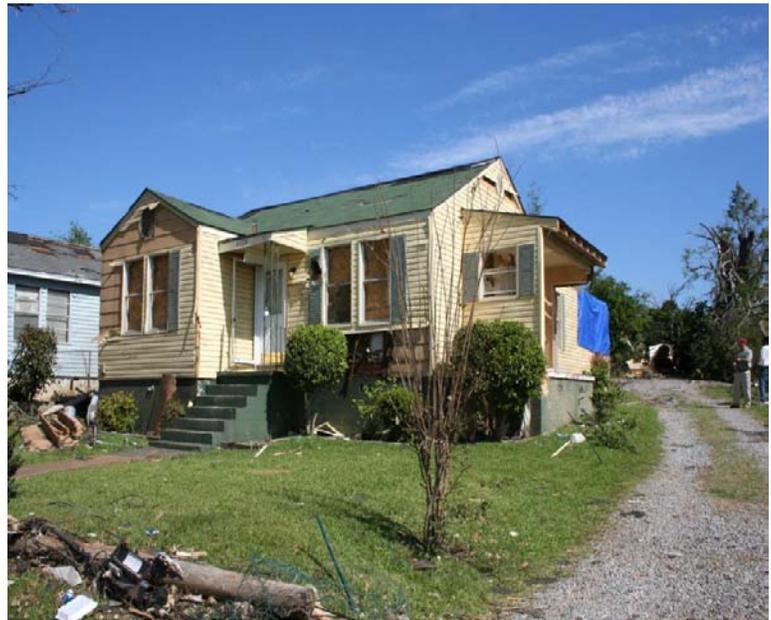
*Figure 4.12 Loss of a wall*

The Degree of Damage on the EF scale for single family buildings is between 2 and 4 with the loss of the porch walls, which suggests wind speeds in the range of 79 - 116 mph with an expected speed of 96-97 mph.

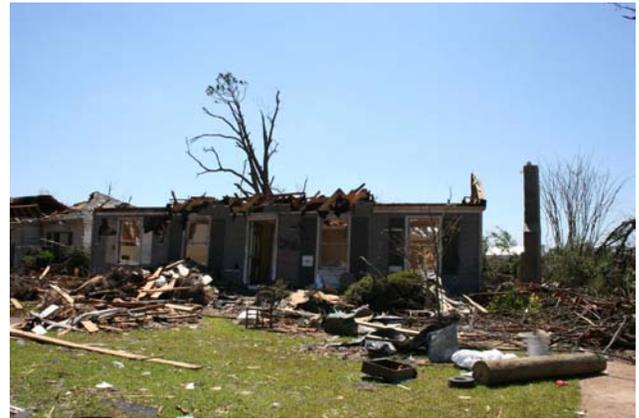
It was a one-story wood frame building built in 1949. It has approximately 1800 sq. ft. of living area. The wind pressure and wind-borne missiles broke the windows which helped lift off the roof. The lightweight building was pushed off the foundation.

*Figure 4.13 Single family dwelling with DOD of 5 to 6.*

The brick chimney was not seriously damaged. The damage sustained was:

- Large section of roof structure removed
- Most walls are standing
- House is shifted on its foundation
- Windows are broken

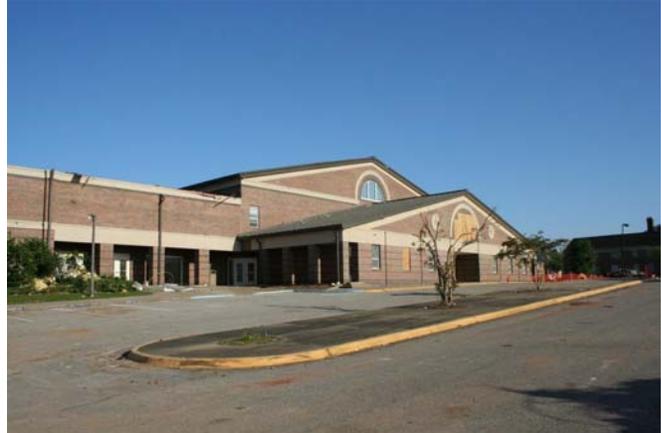
*Figure 4.14 University Place Elementary School*

- The roof and exterior walls of the gymnasium completely collapsed (see Figure 4.15)
- The second floors of two large wings of the school lost roofs and the upper walls collapsed
- Some chords of the steel roof trusses were buckled
- Base plates for the end bearing of the roof trusses on the exterior walls had holes for 2 bolts but no room for the bolts to go through the holes (see Figure 4.16)
- There was minimum steel reinforcing bars extending up from the concrete floor slab that should have been used for splicing with wall reinforcing steel

The Degree of Damage on the EF scale for junior or senior high schools where 2<sup>nd</sup> floor exterior walls are collapsed and the roof structure is damaged is 9, which suggests wind speeds in the range of 121 - 153 mph with an expected speed of 139 mph. If this building type was classified as an elementary school where the roof structure of the gymnasium was lost and the non-load bearing walls collapsed, the DOD is 7 or 8, which suggests wind speeds in the range of 108 – 162 mph with an expected speed of approximately 125 – 140 mph.

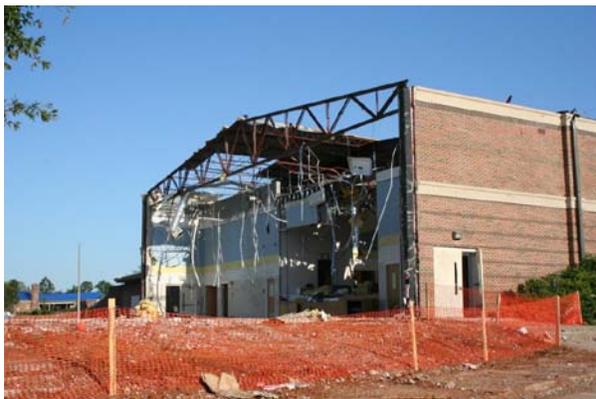
*Figure 4.15 Damaged gymnasium*

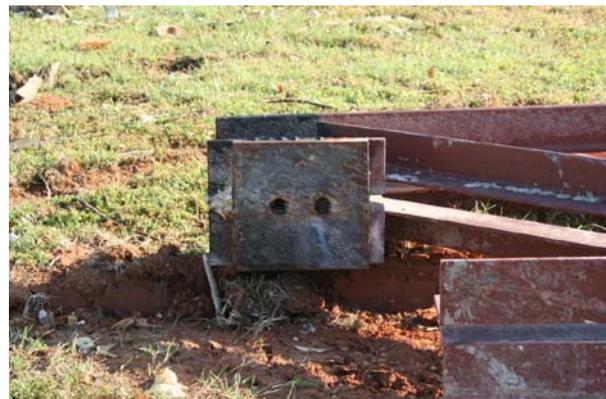
*Figure 4.16: Roof truss that was lifted off during tornado; diagonal member buckled (not shown here).*

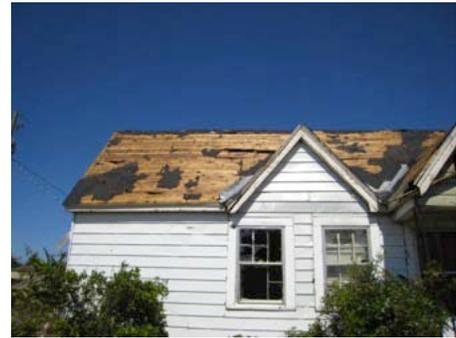
*Figure 5.2: Loss of roof covering*

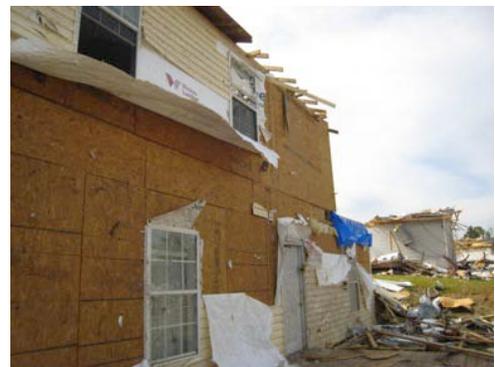
**DOD2: Loss of vinyl/metal siding:**

*Figure 5.3 Loss of siding material*

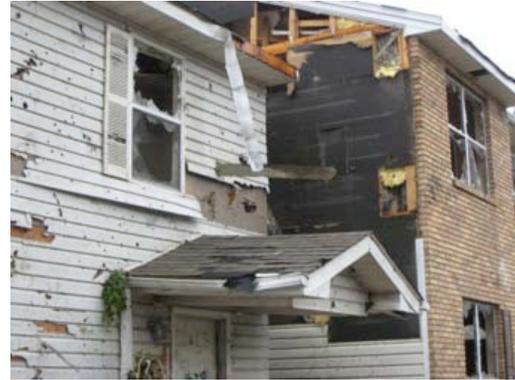
**DOD3: Broken glass in doors and windows:**

*Figure 5.4 Broken windows and doors*

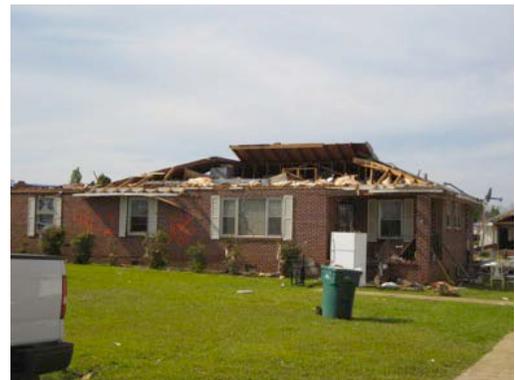
*Figure 5.5 Significant roof damage*

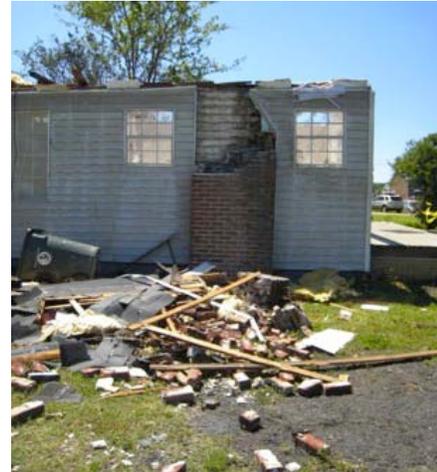
*Figure 5.6 Collapse of chimney*

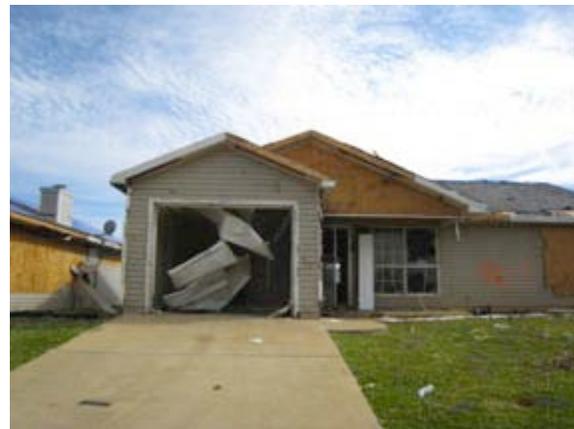
*Figure 5.7 Garage wall blown-in*

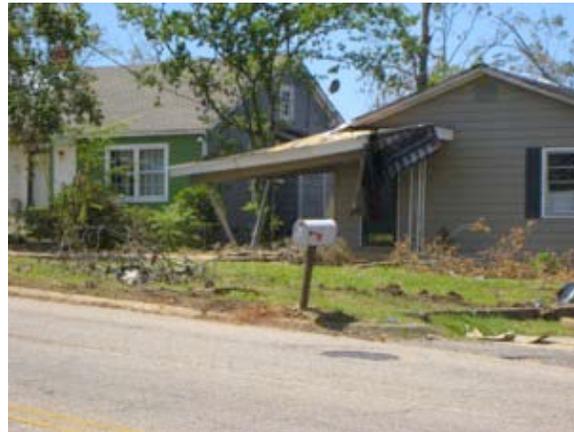
The porch or carport as an extension of the roof system often creates a weak link at its interface with the main structure, i.e. frames back into the roof system of the main portion of the structure. The columns supporting the porch are often inadequately connected to the foundation for winds of this speed. Once these weak interfaces are designed properly, porch or extended roof failure can be reduced for a range of wind speeds beyond 90 mph, perhaps even as high as 140 to 150 mph.

*Figure 5.8 Porch or carport damage*

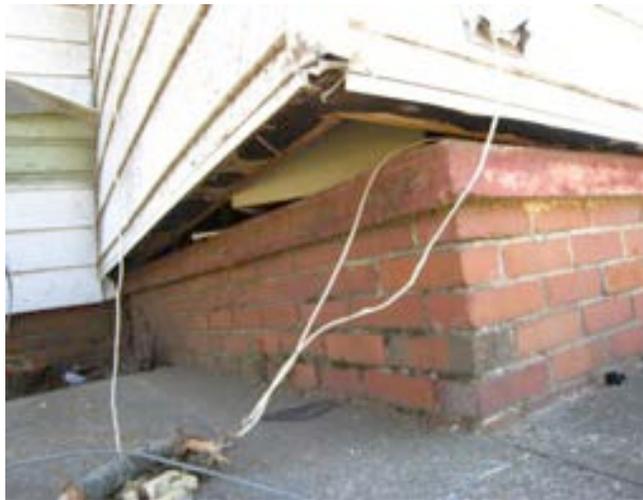
It takes a significant wind speed to shift the entire building off the foundation, even if the foundation is poorly anchored. Although engineering design can address the foundation slippage relatively easily, the level of lateral force may just damage the other structural components if the foundation holds. The design of the foundation must be done in coordination with other lateral wind force resisting systems, but it can be mitigated with proper anchorage similar to earthquake anchoring systems.

*Figure 5.9 House shifting off the foundation*

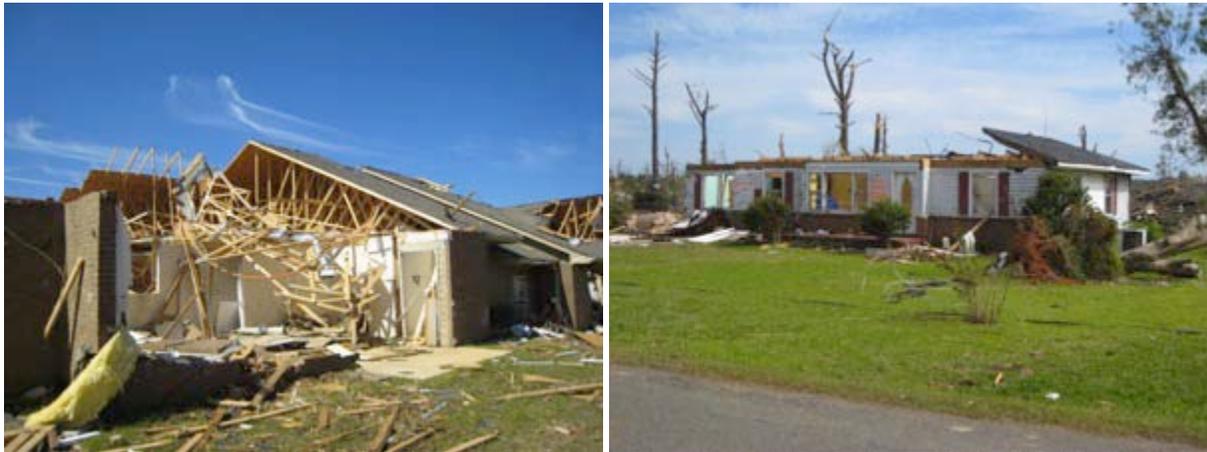
*Figure 5.10 Large sections of roof removed*

The failure of the majority of the roof structure may be mitigated through the use of connection hardware and non-conventional sizes for roof trusses. This may be a good practice for customized design or specific buildings. Due to the large uplift pressures on the roof, just improving the connection of the roof truss to the wall may not be sufficient. The roof ridge connections may also need to be strengthened so the roof does not come apart at the ridge.

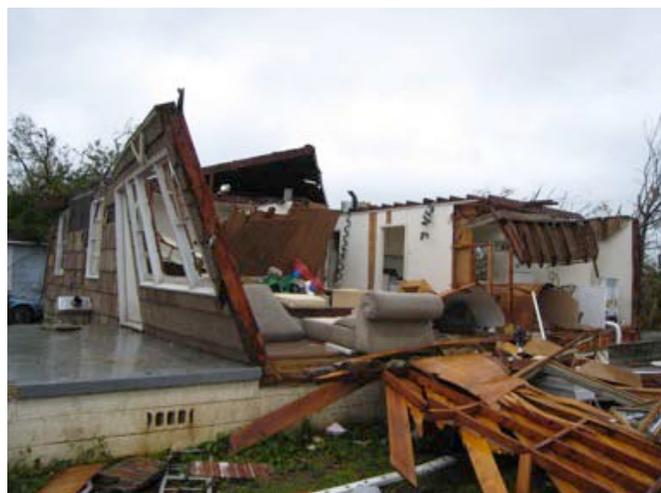
*Figure 5.11 Exterior walls collapse*

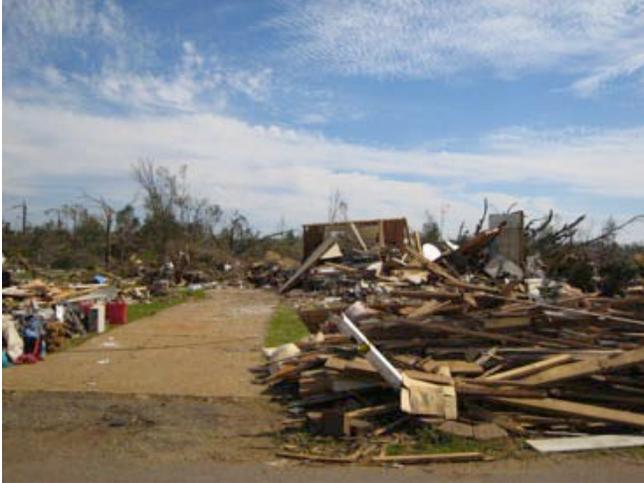
**DOD8: Most walls collapsed:**

*Figure 5.12 Most walls collapsed*

A safe room or shelter is the best means of protecting the lives of the occupants in the event of wind speeds in excess of 160 mph.

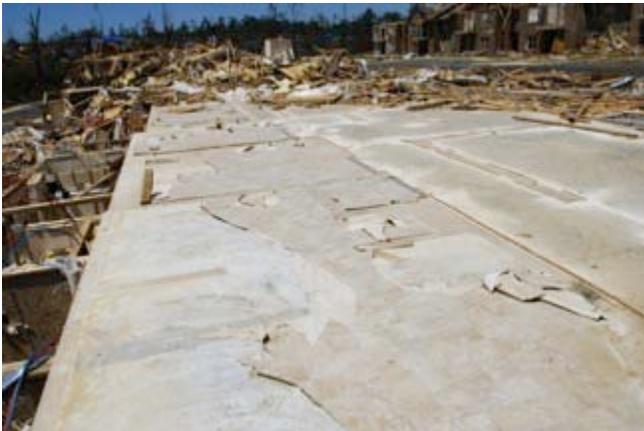
*Figure 5.13 Slab swept clean in newer 2010 construction*
