# **Damage Study and Future Direction for Structural Design Following the Tuscaloosa Tornado of 2011**

**David O. Prevatt, Ph.D., P.E., University of Florida, Gainesville, FL**  
**John W. van de Lindt, Ph.D., University of Alabama, Tuscaloosa, AL**  
**Andrew Graettinger, Ph.D., University of Alabama, Tuscaloosa, AL**  
**William Coulbourne, P.E., Applied Technology Council, Rehoboth Beach, DE**  
**Rakesh Gupta, Ph.D., Oregon State University, Corvallis, OR**  
**Shiling Pei, Ph.D., P.E., South Dakota State University, Brookings, SD**  
**Samuel Hensen, P.E., Simpson Strong Tie, Pleasanton, CA**  
**David Grau, Ph.D., University of Alabama, Tuscaloosa, AL**

July 27, 2011

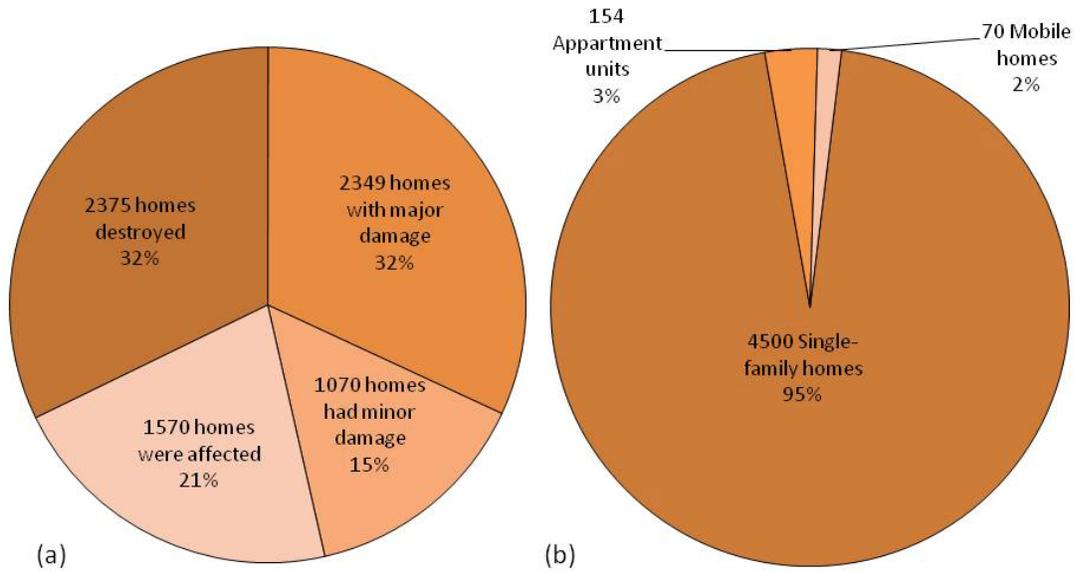
Figure 1.7 (a) Number and level of damage of homes in Tuscaloosa County affected by the 27 April 2011 and (b) Number and type of homes in Tuscaloosa County (7 May 2011 Tuscaloosa News).

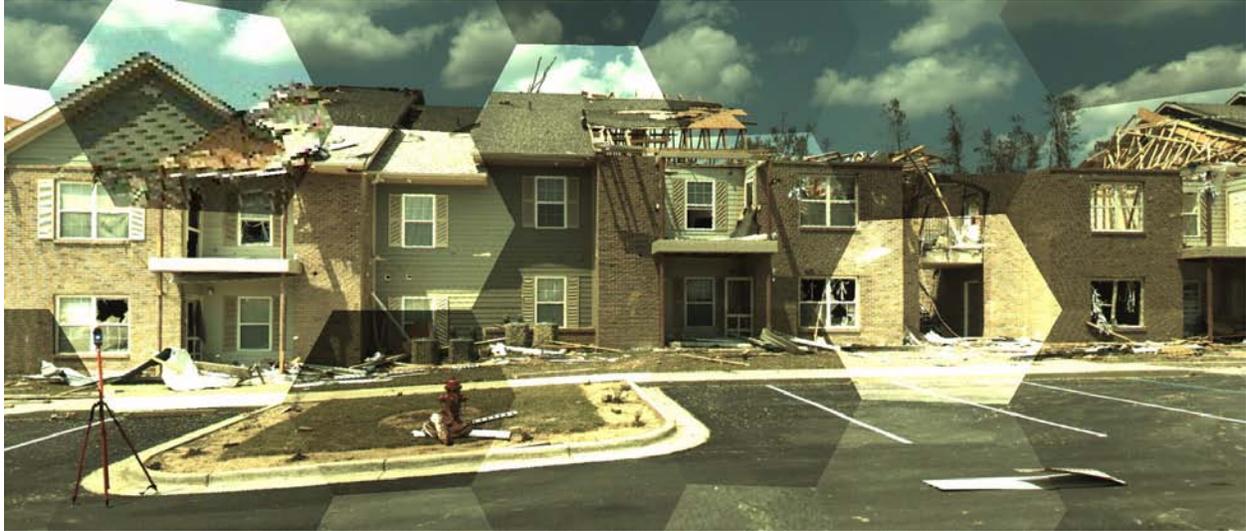
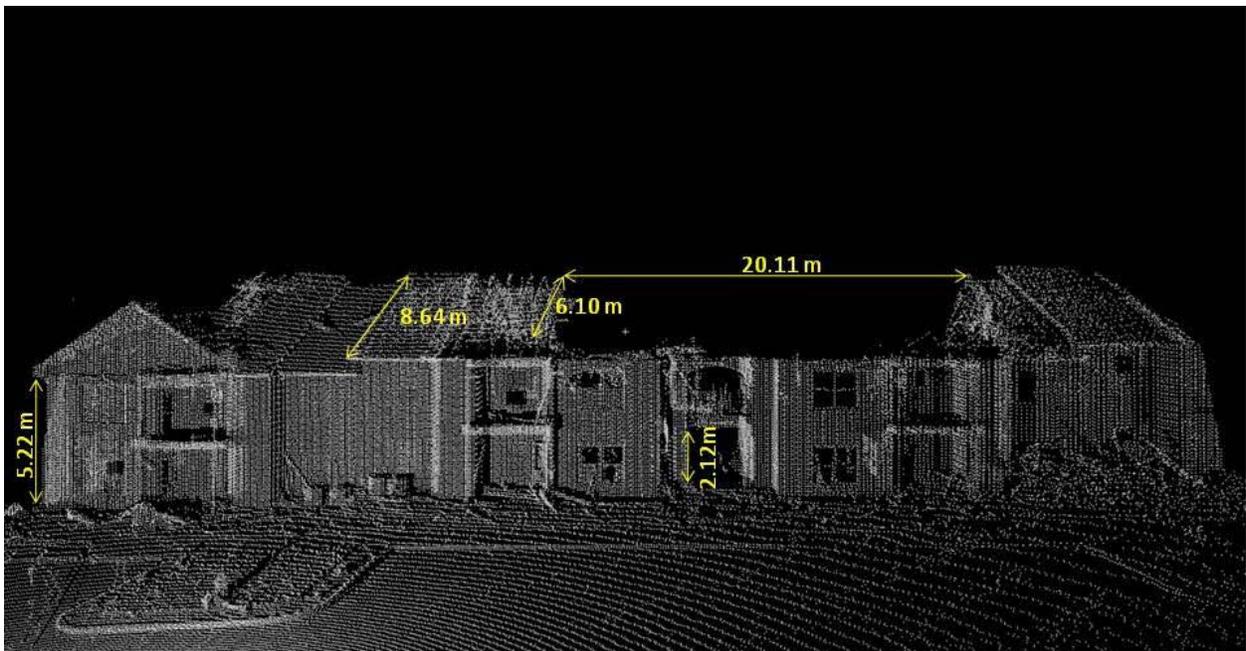
Figure 2.8. (a) Panoramic view of apartment complex and (b) equivalent measurement of damage extent with point clouds view

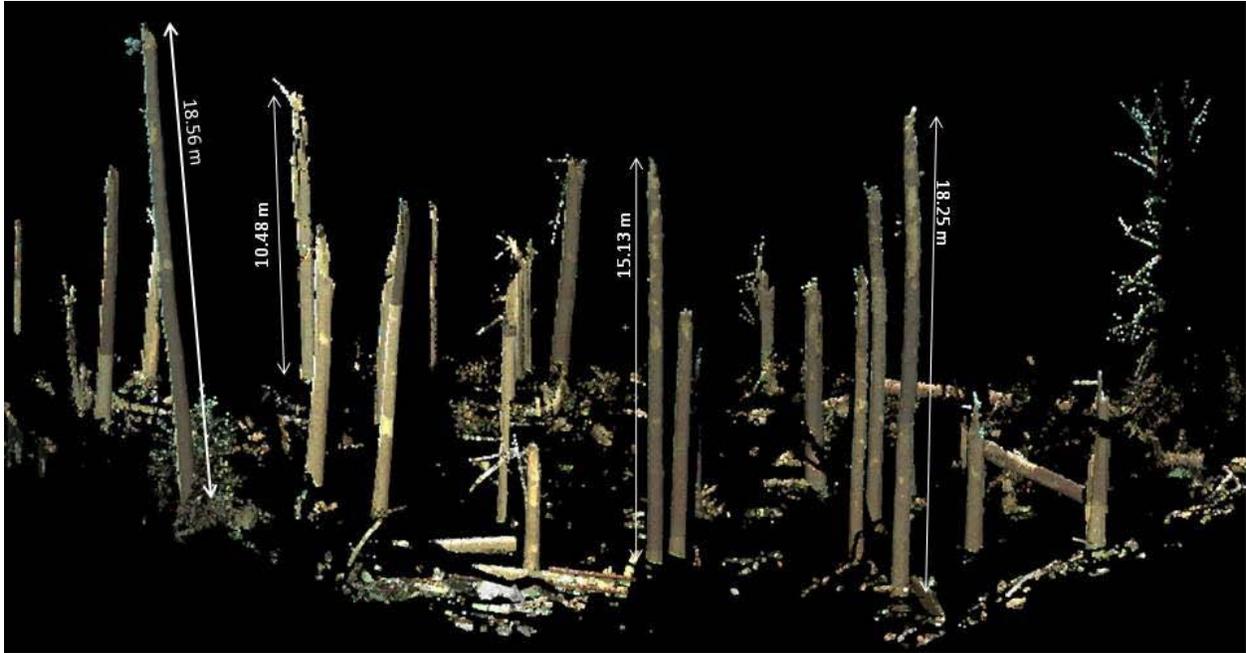
Figure 2.9. Measurement of debarked trees height

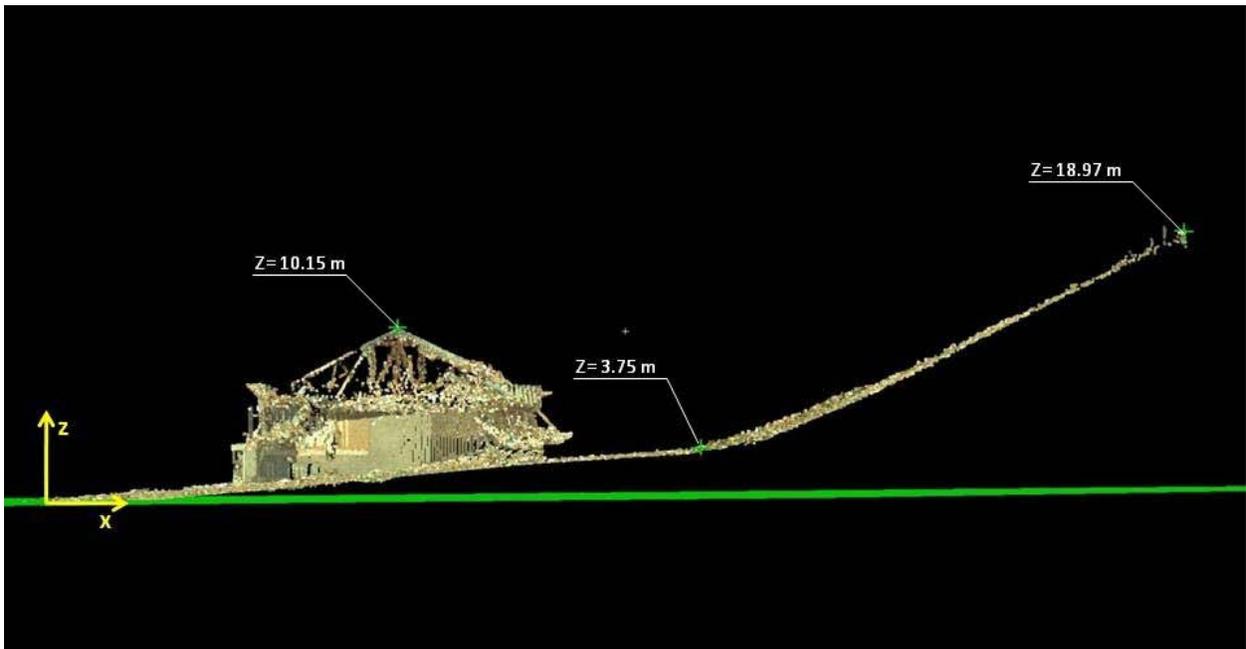
Figure 2.10. Elevation measurements across a damaged apartment and nearby terrain profile
